DOI: 10.20535/2707-2096.7.2022.267605
UDC 622.271

EXPERIENCE IN STRENGTHENING UNDERGROUND PEDESTRIAN CROSSINGS IN WATER-SATURATED CITY SOILS

The proposed solutions have been implemented and the technical condition of underground structures is being monitored. Underground pedestrian crossing at the intersection of Mineralna-Ukrainska streets in Kyiv. The structure was erected in 2011 and is an underground pedestrian crossing, the spatial rigidity of which is ensured by a framework made of monolithic reinforced concrete.

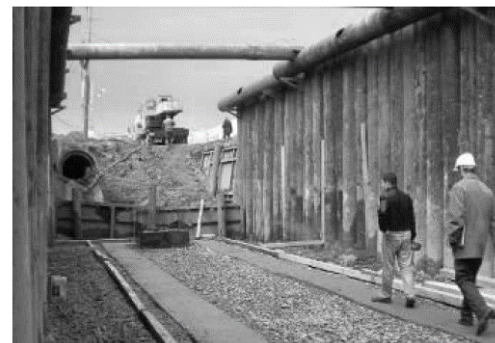
During the construction of an underground structure in an open way in water-saturated soils, along the entire perimeter of the pit, a sheet pile fence is made of steel pipes with a pointed lower end, hammered with the help of a pneumatic plunger (Pic. 3, 4, 5).

Pictures 3,4 - Underground pedestrian crossing at the intersection of Mineralna – Ukrainianska streets in Kyiv, 3 - Longitudinal section along the transition with swamps and depression curve; 4 - A pit with walls fastened with a sheet pile

It was established that the main reason for the formation of cracks in the structures of the underground passage, the concentration of which is recorded in the walls and covering of the middle zone of the long tunnel of the box cross-section, is: uneven settlement of the slab bottom of the tunnel part of the passage, at the base of which are water-saturated soils with different degrees of compressibility within the con. foundation Uneven deformations of the subsidence of the extended tunnel structure are associated with the process of reducing the strength characteristics (angle of internal friction φ , specific adhesion c) and increasing deformability (decreasing the modulus of deformation E and increasing the subsidence s) of the base soils, caused by the incorrect application of the principle and technology of temporary construction water - sumps located at a considerable distance from each other at the ends of the tunnel being erected (Pic. 6, 7).

The formation of a depression curve between locally located sumps with an uneven lowering of the high level of groundwater along the tunnel trunk created a new stressed-deformed state within the soil massif located under the sole of the bottom.

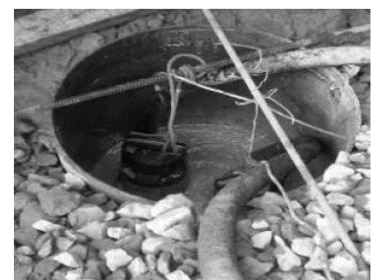
Pictures 5,6,7 - 5 – Trunk part of the transition; 6 - The heads of the elements of the submerged sheet pile and the frontal part, 7 - sump reinforcement piles with a water pump
